# Cane Creek and Little Cane Creek Watershed Management Plan to Address E. Coli Impairment, Oconee County, SC

September 2018

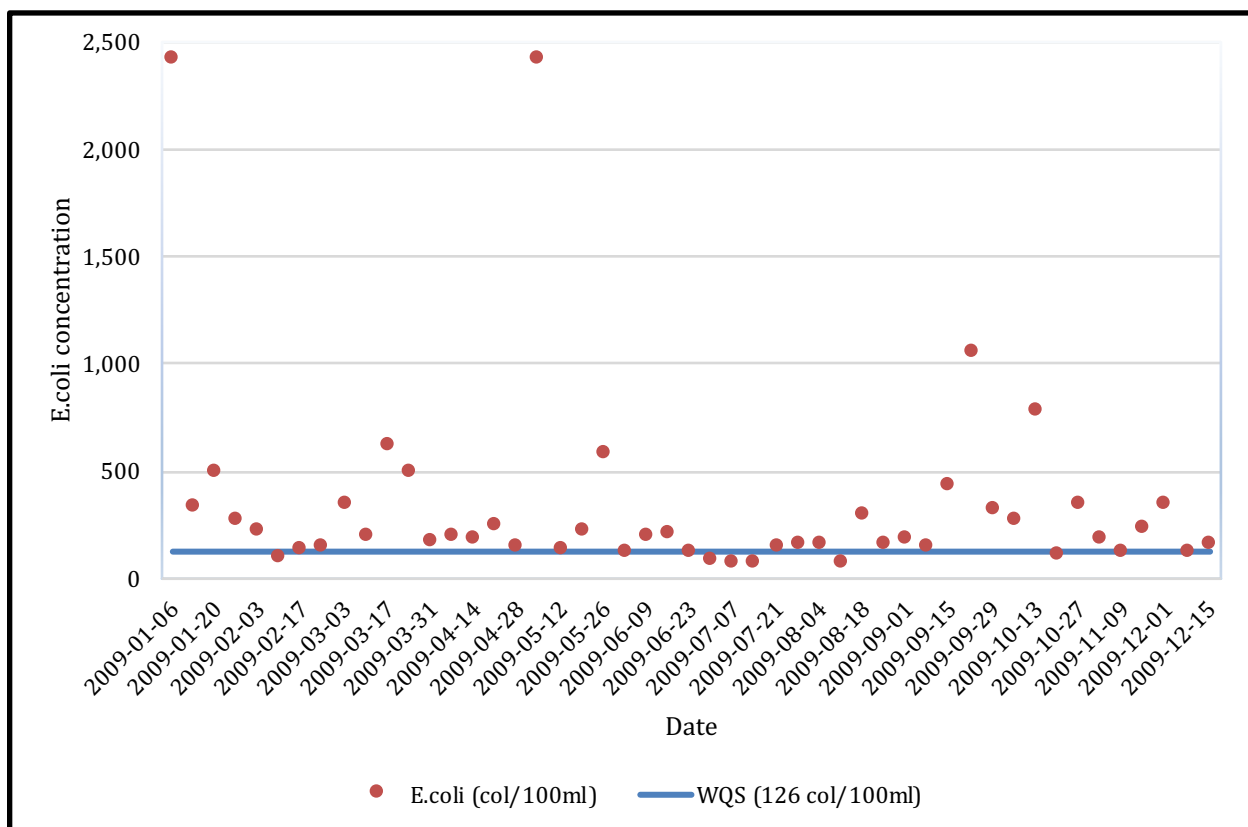
Fig. 4. *E. coli* results at SV-342 on Cane Creek in 2009, plotted against the water quality standard for single grab samples (126 col/100mL).

The stations of significance to this watershed plan are those used in the development of the fecal coliform TMDL. SV-342 is on Cane Creek; SV-343 is on Little Cane Creek (Figs. 4 and 5). Both have been monitored since 1999 for a full suite of water quality parameters. 2009 is the only year each were monitored for *E. coli* and the last year of data collection at these two stations. In 2009, 49 results are available for *E. coli* at both monitoring locations.

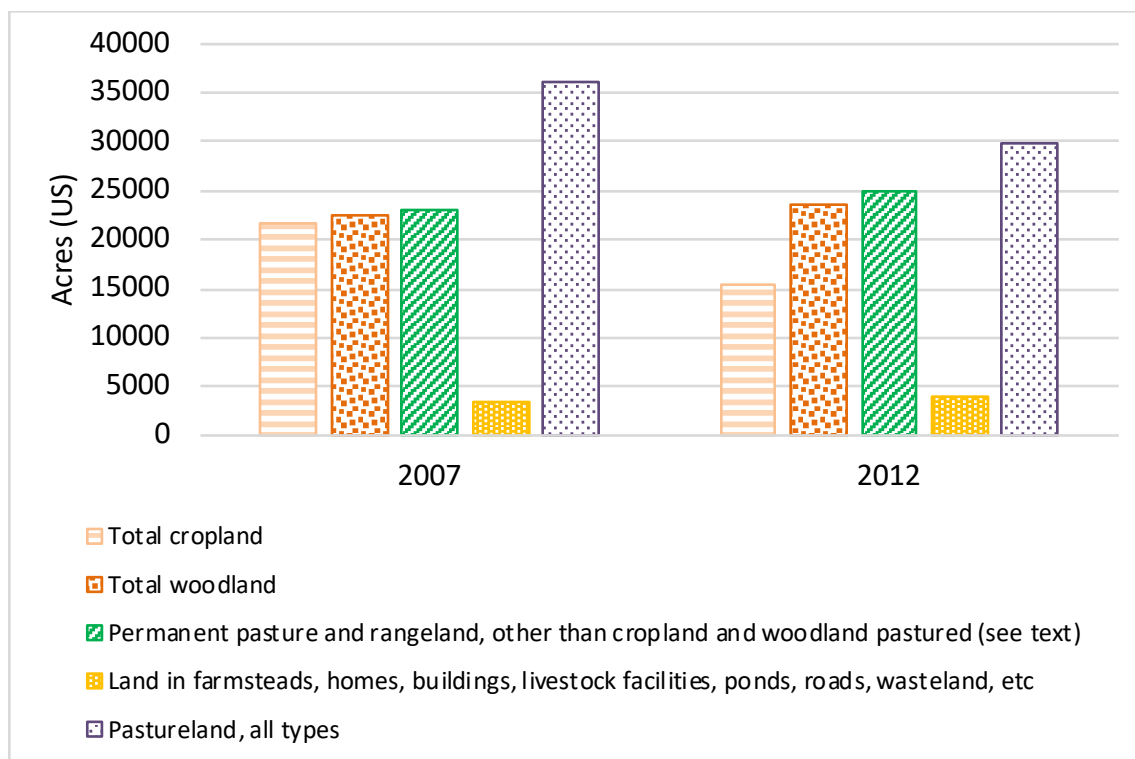
Fig. 7. Land in farms in Oconee County according to use - 2012 and 2007.

Classes	2007	2012	2007	2012
	Acres (US)		Percentage (%)	
Total cropland	21,566	15,401	20.21	15.76
Total woodland	22,601	23,583	21.18	24.13
Permanent pasture and rangeland, other than cropland and woodland pastured	23,141	24,838	21.68	25.41
Land in farmsteads, homes, buildings, livestock facilities, ponds, roads, wasteland, etc	3,400	4,049	3.19	4.14
Pastureland, all types	36,021	29,865	33.75	30.56
Total	106,729	97,736	100	100

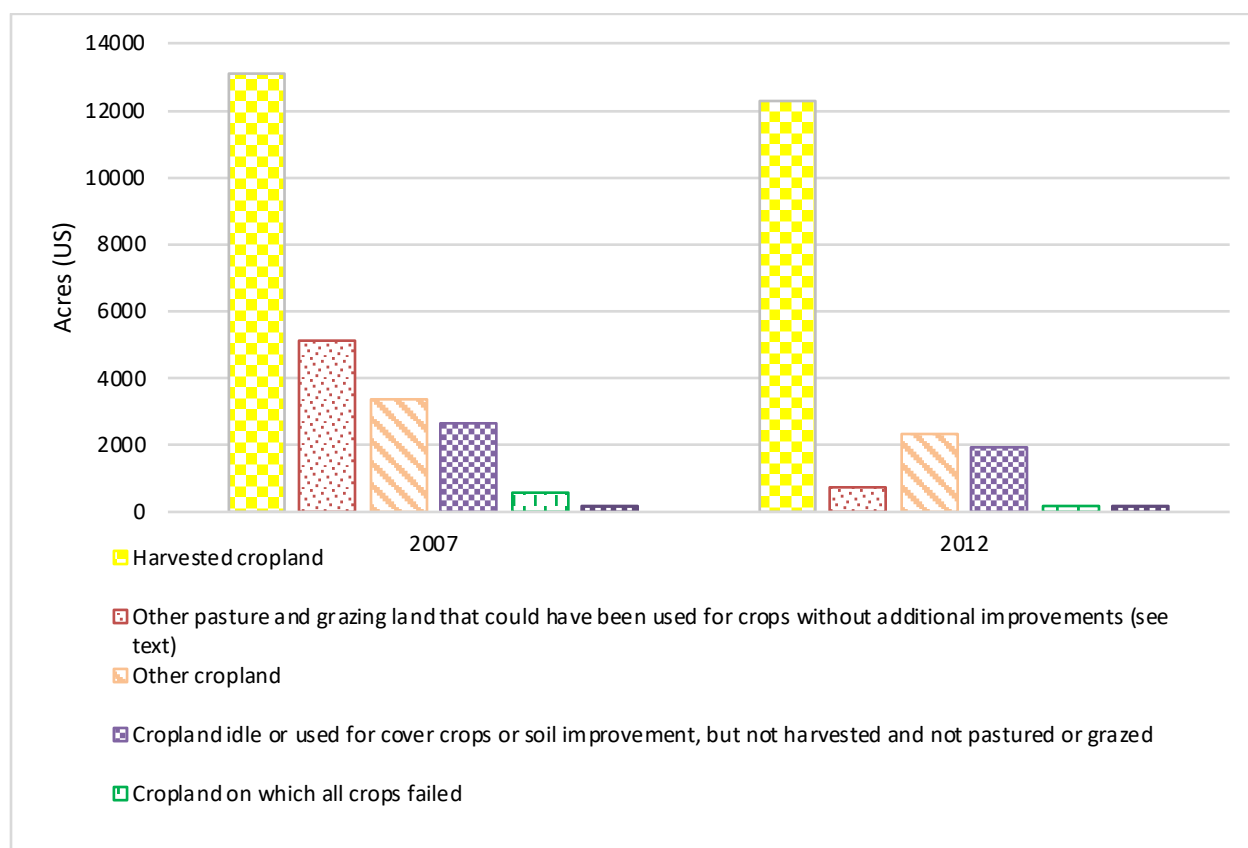
Fig. 8 The total cropland area distribution of Oconee County from 2007 to 2012.

The total cropland area in Oconee County, according to the NASS report, showed a significant decline from 24,943 in 2007 to 17,755 in 2012, Table 6, Fig. 8. The dominating change was in the pasture and grazing land and cropland idle area.

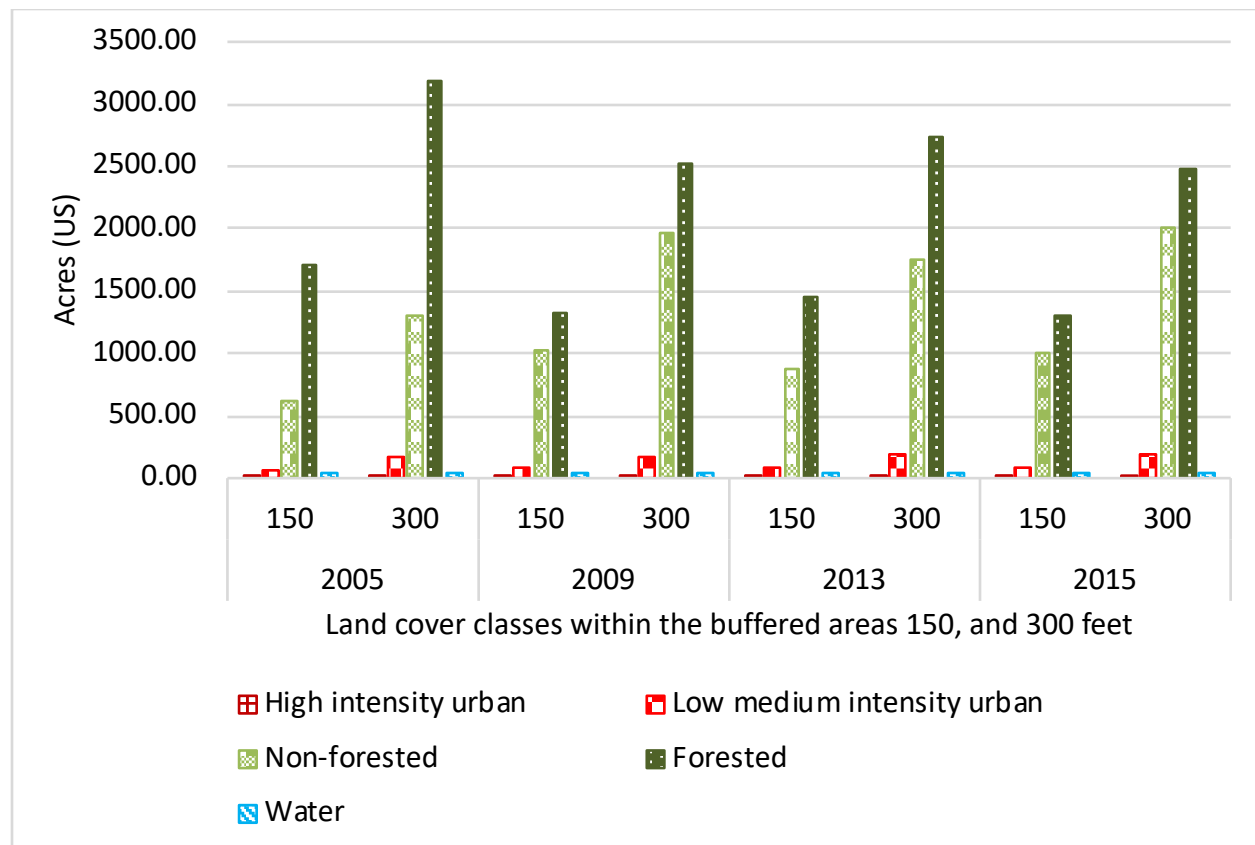
Fig. 12. Land cover classes and change within the buffered areas of 150 and 300 feet.

Land use change is an especially important consideration when it is occurring adjacent to waterbodies, as water quality mimics its neighboring land use due to runoff and quality can be characterized by the conditions of use. Following the work of the Coastal Riparian Buffers Analysis conducted for the EPA in Connecticut (University of Connecticut NEMO 2007) the analysis of land use change in the riparian corridor was completed at two buffer widths - 150 feet, and 300 feet on each side of open water - over the selected time intervals (Fig. 12 and Fig. 13).

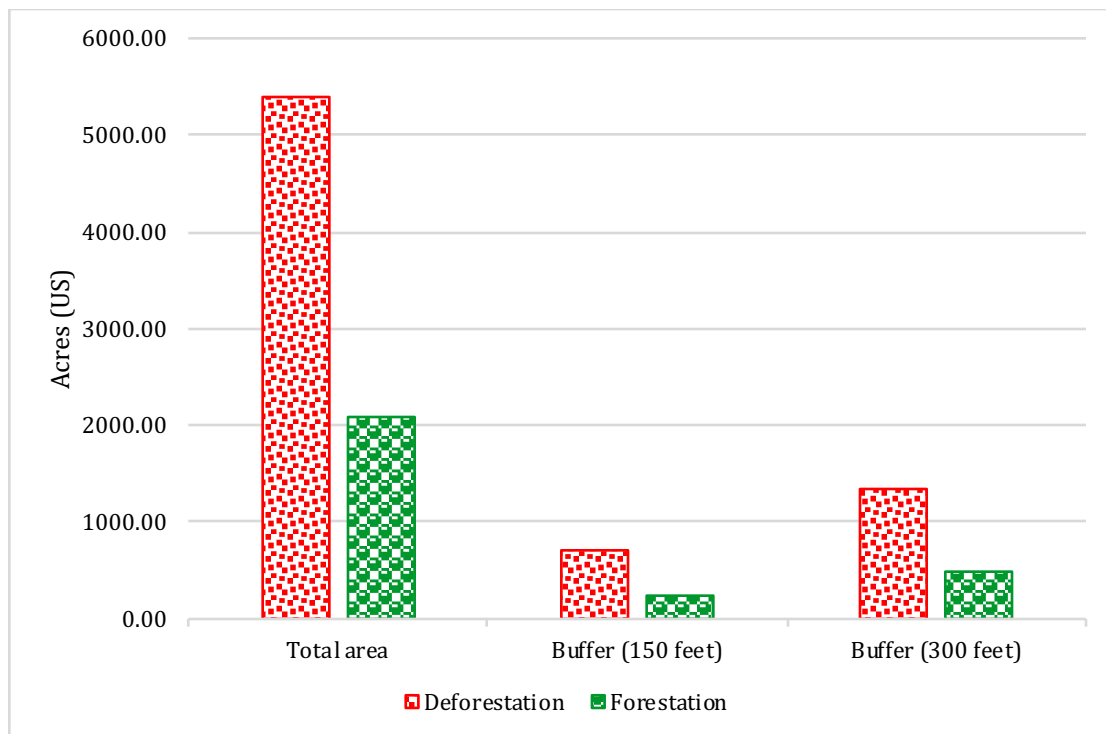
Fig. 15. Total area of deforestation in the watershed and selected buffer widths from 2005 to 2015.

Classes	Overall area		150 feet		300 feet	
	Acres (US)	(%)	Acres (US)	(%)	Acres (US)	(%)
Deforestation	5,400.79	28.93	717.44	29.17	1,332.52	28.21
Forestation	2,093.38	11.21	227.88	9.27	476.34	10.08

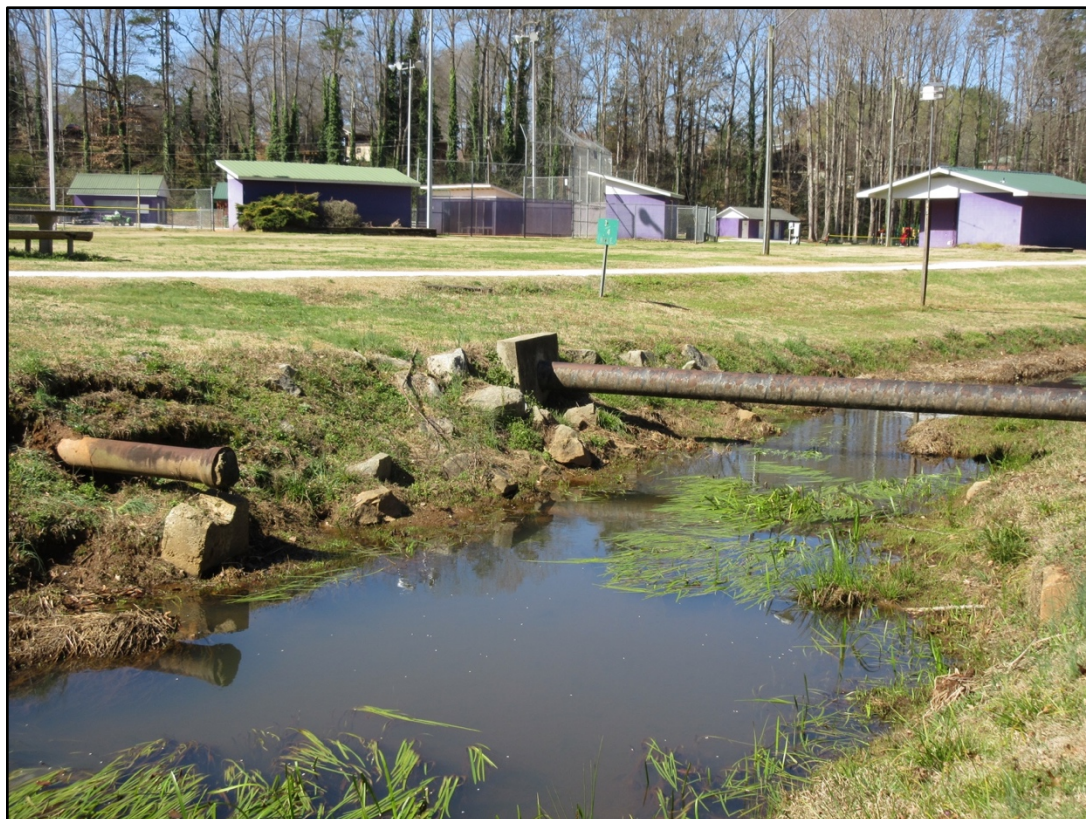
*Fig.18. Previously sealed and replacement sewer lines hover just a few feet over unnamed tributary leading to Cane Creek, which runs through Sertoma Field, Walhalla, SC.*

documented as a source of overflows to Cane Creek. These occurrences have been noted in the most frequently used public park in the area, Sertoma Field. This public park includes the main sewer line, which parallels and then crosses a tributary to Cane Creek and concrete cinder cones house risers and manholes from the sewer line. Sertoma Field is the most popular and most frequented park in the area, where baseball games, track, disc golf, and other recreational amenities are available to the public, as well as several community festivals such as Walhalla's annual Oktoberfest.

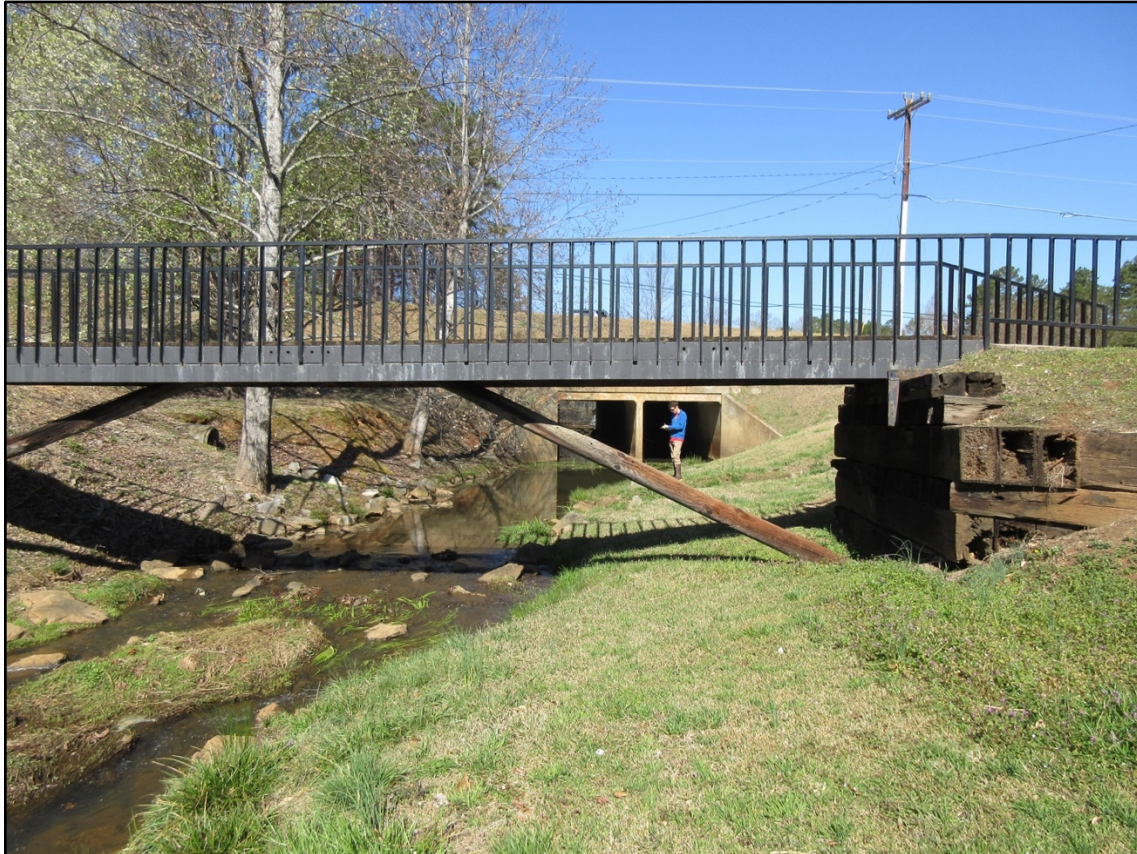
*Fig. 19. Tributary to Cane Creek from neighborhood pond, after it passes under Highway 183 and enters into Sertoma Field.*

length and for the majority of the year. The tributary is shaded by a few large trees, but predominantly has turf extending to the edge of the low bank (Fig. 19). Though not observed during the development of this watershed plan, stakeholders have stated that this park and adjacent parking lot floods several times per year. The adjacent parking lot is not curbed and is at a distance between 15 and 30 feet from the tributary for its full length. The opposing side includes utilities, walking path, and turf to the edge of the waterway (Fig. 20).

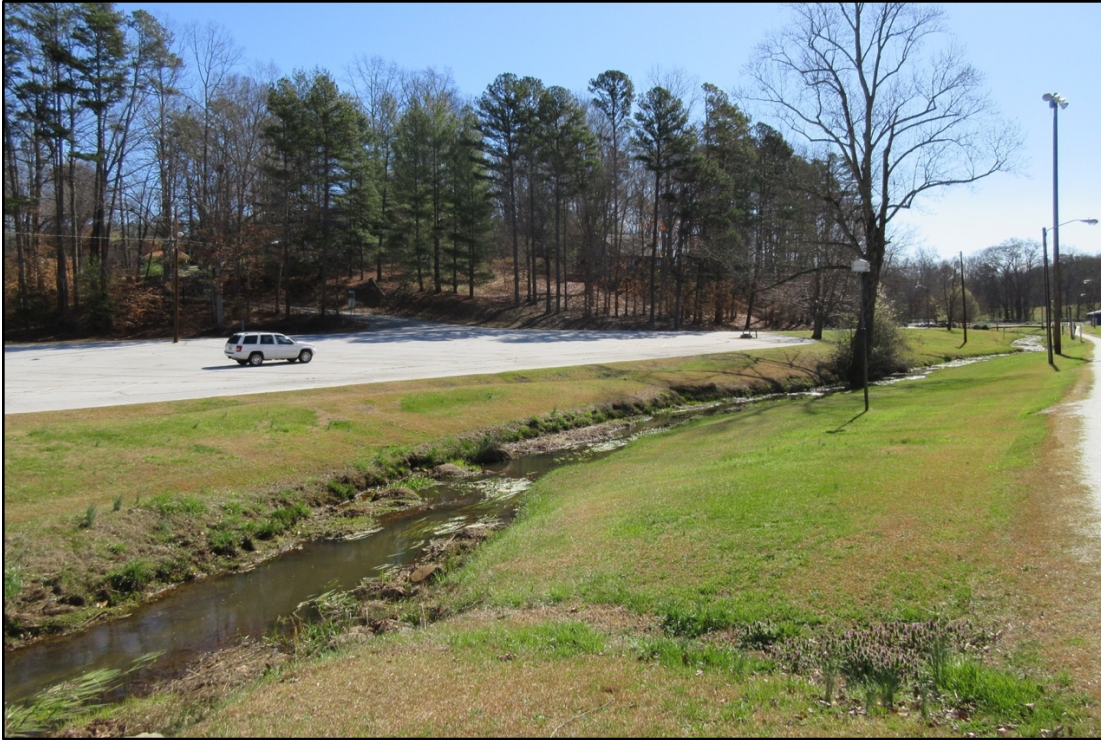
*Fig. 20. Unnamed tributary to Cane Creek is managed with mowed turf to the edge of the waterway, with little shading, and excessive growth of aquatic vegetation.*

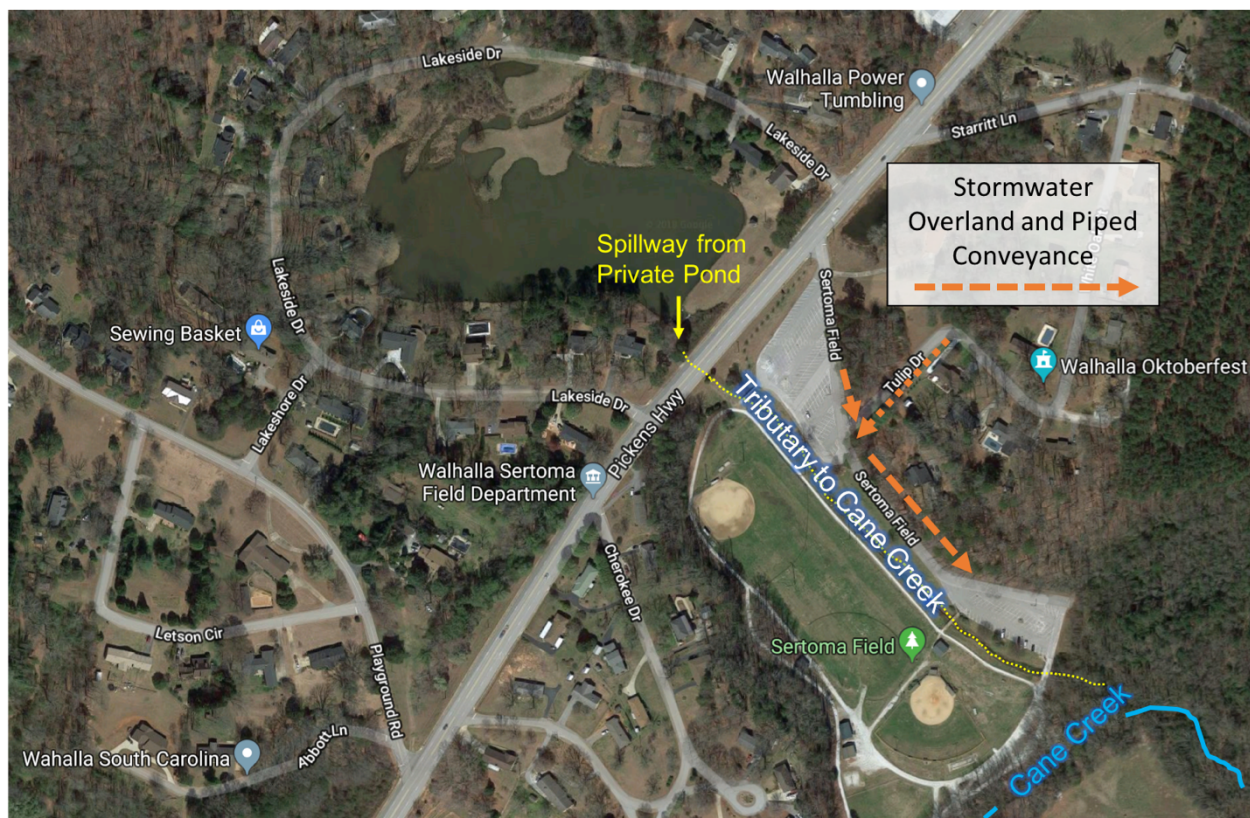
Fig. 21. Sertoma Field and conveyances of runoff and pond input to Cane Creek.

Across the parking lot, a relatively small neighborhood lies uphill, with an access road perpendicular to the park road (Fig. 21). Stormwater infrastructure has been observed as buried under sediment and covered with debris. There is little evidence of maintenance, and stormwater likely bypasses the pipe to flow over land and asphalt to the unnamed tributary and Cane Creek, which flows along the outer perimeter of the park. Residential stormwater can transport fecal bacteria from domestic and feral animals, trash containers, ruminants, wildlife, and septic system leachate.

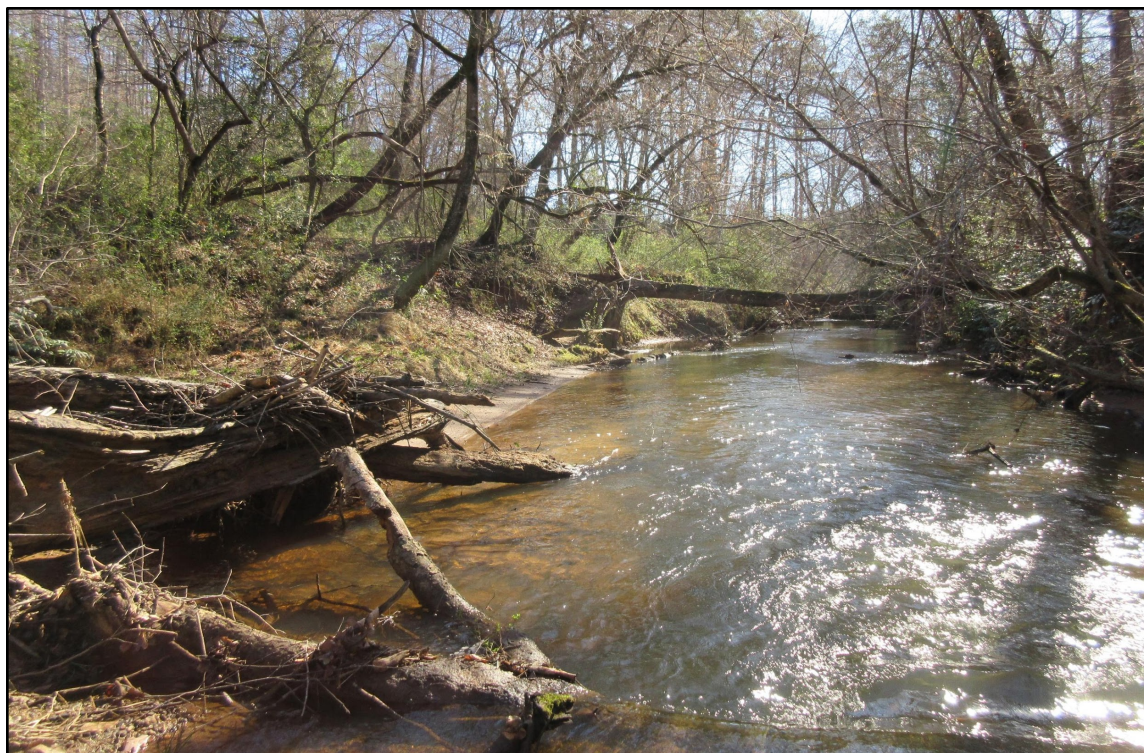
Fig. 22. A corridor of leaning and downed trees in the lower reaches of Cane Creek.

Field observations showed widespread loss of large trees in the riparian corridors of Cane and Little Cane Creeks (see Fig. 22). This was further documented in the land use change analysis that revealed 28% loss of trees within 300' of stream between 2005 and 2015. With loss of large trees, comes streambank failure and streambank sediment deposition into the stream. Furthermore, the large downed trees slow stream flow and remove the natural flushing mechanism that occurs naturally during large storm events.

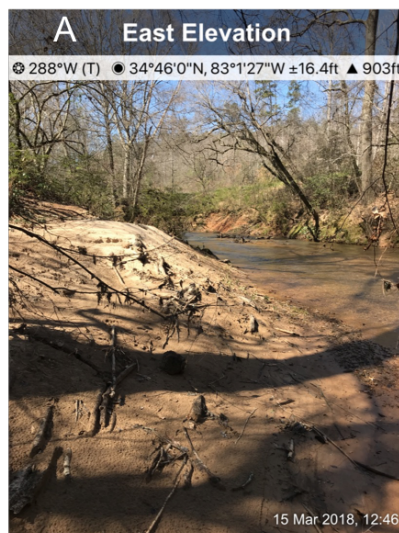
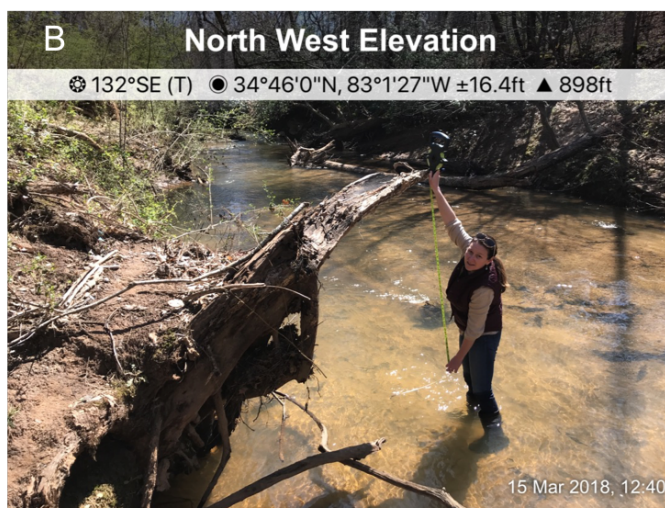
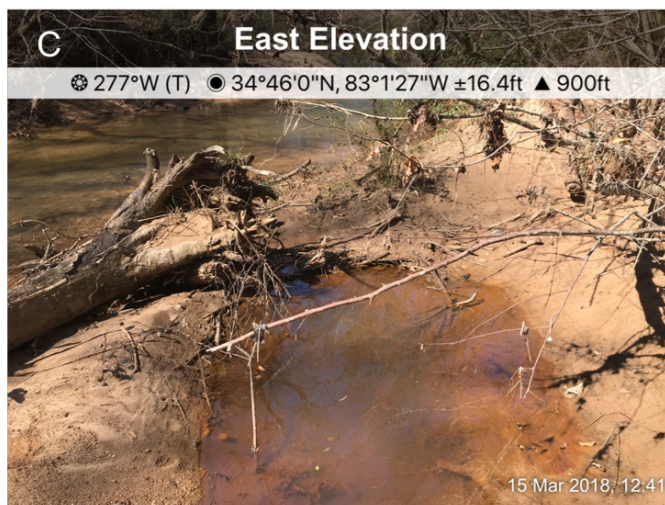
Reach of Cane Creek showing A) Sediment deposition along channel bend; B) Downed tree; C) Space left by downed tree and sediment available for stream bed deposition

Fig. 23. Pictures of lower Cane Creek displaying the repeated cycle of trees on the cusp of collapsing into the stream, sediment accumulation, trees already have fallen into the stream, and vulnerable sediment for deposition.

Given the characteristic failing of large trees in the stream corridor, the incurred deposition of sediment due to bank loss, and the accumulation of sediments in the stream bottom, it is believed that this series of events, paired with a regular input of fecal polluted runoff or leachate is a significant cause of the regularly observed bacteria impairment in the surface waters of Cane and Little Cane Creek near their DHEC monitoring stations (see Fig. 23).

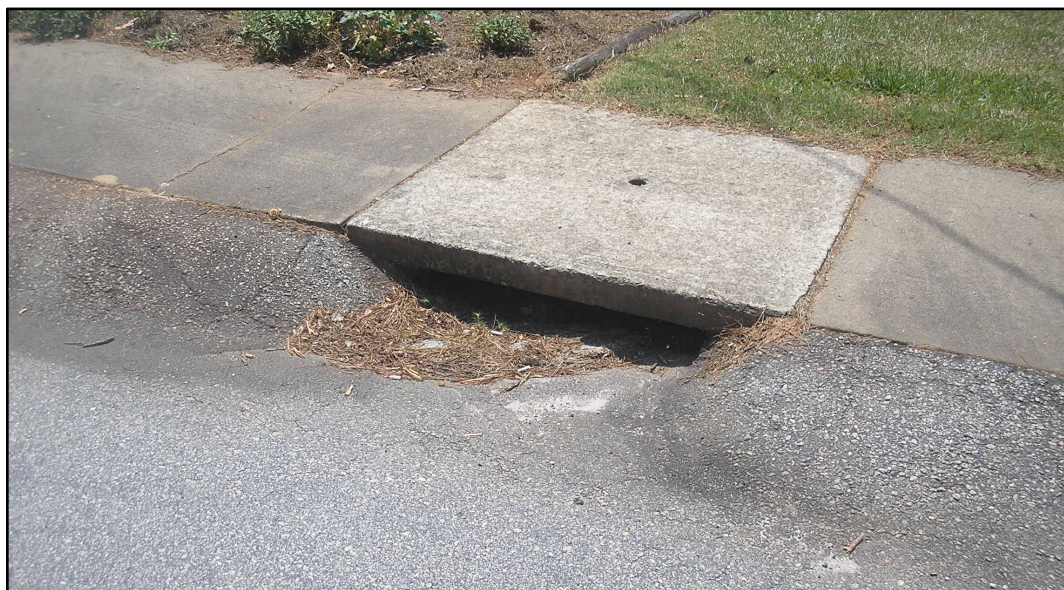
Fig. 25. Catch basin with landscape and natural debris in the basin.

The catch basins within the Cane Creek Watershed are predominantly in Walhalla and all are owned by the SC Department of Transportation (SC DOT). The city currently does not have capacity to vacuum or maintain the interior of these chambers, nor the ownership to do so. It would be an improvement to the quality of receiving waters for annual maintenance to occur, or a schedule developed suitable for the needs of downtown.

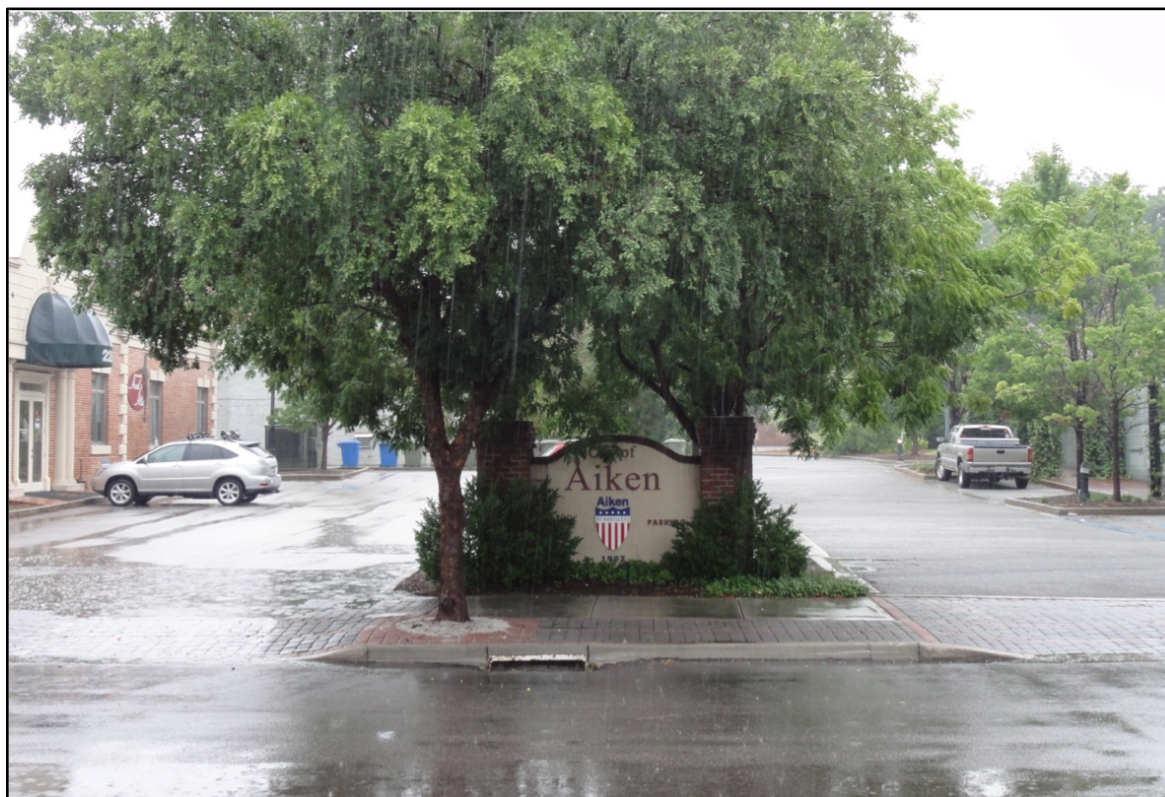
*Fig. 28. This image from Aiken, SC demonstrates the ability of a porous asphalt road (right) to quickly infiltrate rain water, in comparison to standard asphalt road (left) showing puddles (Source: Calvin Sawyer, Ph.D., Clemson University).*

While the porous asphalt is being installed, stormwater infrastructure should be eliminated along the parking lot and collected from Tulip Drive, which is perpendicular to the park road. With the porous asphalt in place, this stormwater will be more effectively treated than traditional pipe collection (Fig. 28).
